Tornadoes - June 28th 2018 Damage Survey Results from Carter County, MT and Harding County, SD

During the evening hours on June 28th, a severe thunderstorm moved across Carter County producing golf ball or larger hail, straight line winds 70-80 mph, and as many as 5 tornadoes as it moved toward the South Dakota border.

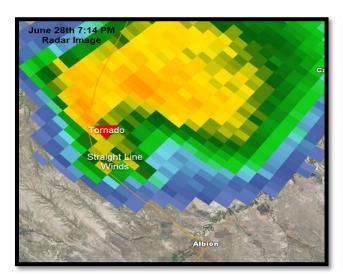
Around 7:17 PM the first tornado was spotted crossing SR 323 in Carter County about 12 miles north of Albion in the Finger Butte Area. This tornado was spotted by a rancher about a mile to the south. His property sustained straight line wind damage on the south side of the storm. Metal roofing was peeled back and in other portions lifted off, consistent with winds around 70-80 mph.

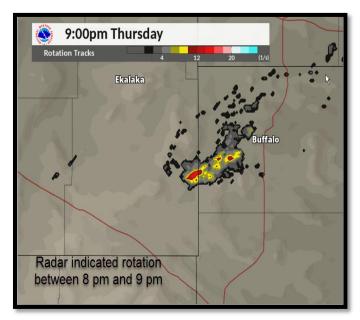
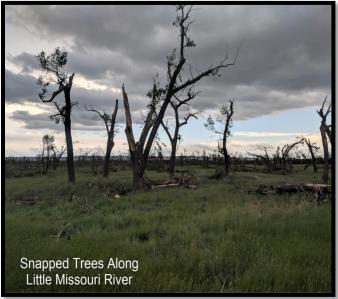
Damage survey and eye witness accounts confirm the tornado initially moved north-north-east along the Little Missouri River. As it approached the river it intensified to 120 mph (EF-2) producing an increasingly wider swath of snapped trees several hundred yards wide. The tornado started to turn more to the east at this time, moving on a northeasterly track as it crossed the Little Missouri and moved across the Montana/South Dakota border.

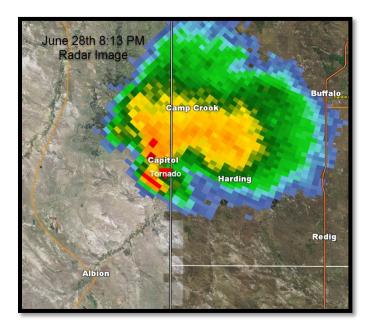
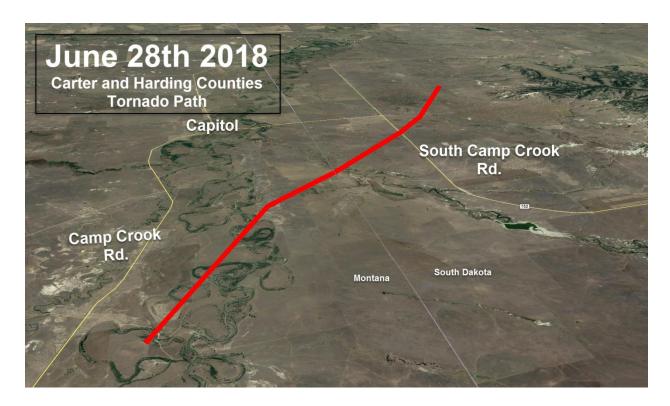
In South Dakota, this storm increased to an estimated ½ mile wide and damage observed was consistent with an EF-3 tornado rating, with winds estimated at 136 mph. Preliminary damage in South Dakota included one home destroyed, shed destroyed, trailer toppled over, heavy hay bales moved, along with tree damage (even debarked in some cases). Local residents reported finding numerous dead deer in the debris along the river where the tornado crossed the tree line. Damage in South Dakota is assessed by the National Weather Service in Rapid City and further updates to this information can be found at weather.gov/rapidcity.
